# Kansas Municipal Energy Agency

## Distribution System Assessment for the City of Garnett, Kansas Final

October 11, 2016

Project No. 16-0178

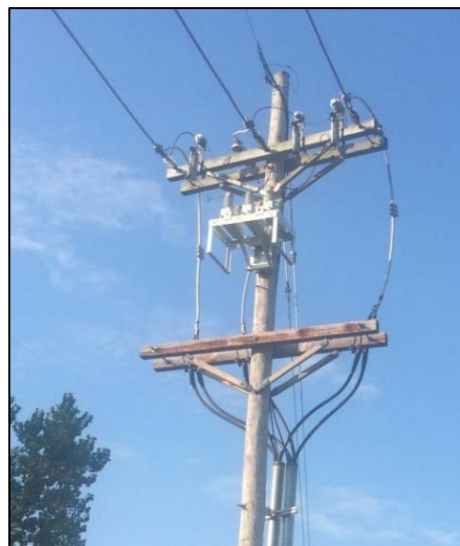
There are some temperature control capacitor banks on the system while the rest are manually controlled. Sega recommends expanding the use of temperature-controlled capacitor banks to reduce maintenance time in switching them on and off during transitional temperature periods such as during fall when daytime temperatures can be in the 80s and nighttime temperatures can decrease to the mid 50s.

**Figure 3.1 - Capacitor Bank Without Controls**

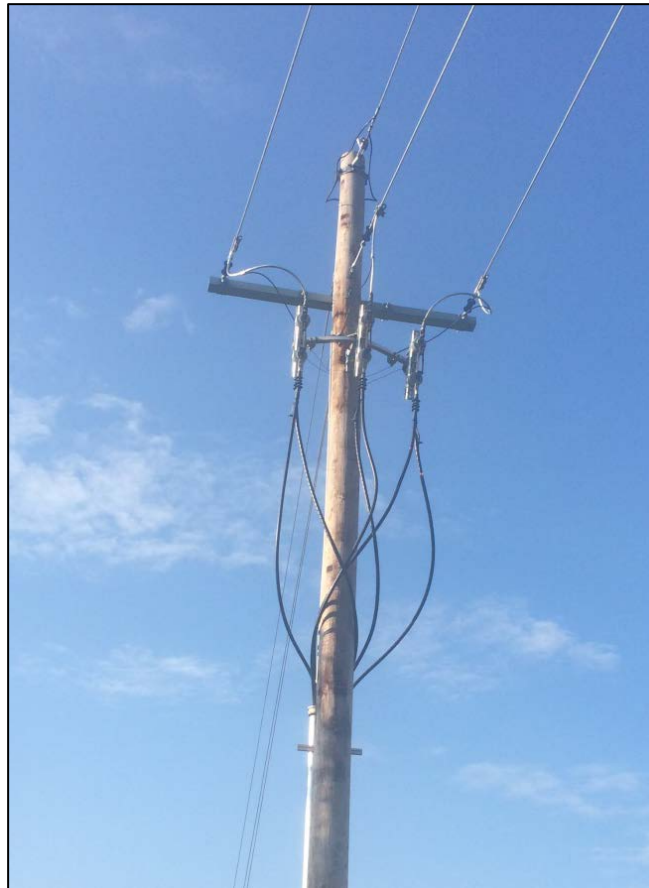
Sega recommends installing lightning arrestors at all underground dip/riser poles. Most poles with transformers have arrestors installed but there are not lightning arrestors on the underground dip/riser poles. The capacitance of underground circuits is quite high compared to overhead circuits. Due to this capacitance, a lightning surge is likely to double its voltage in the underground circuits. The arrestors at these locations would prevent a lightning strike from affecting the underground cable which would take longer to fix if there was a fault.

**Figure 3.3 - Missing Arrestors on Riser Pole**

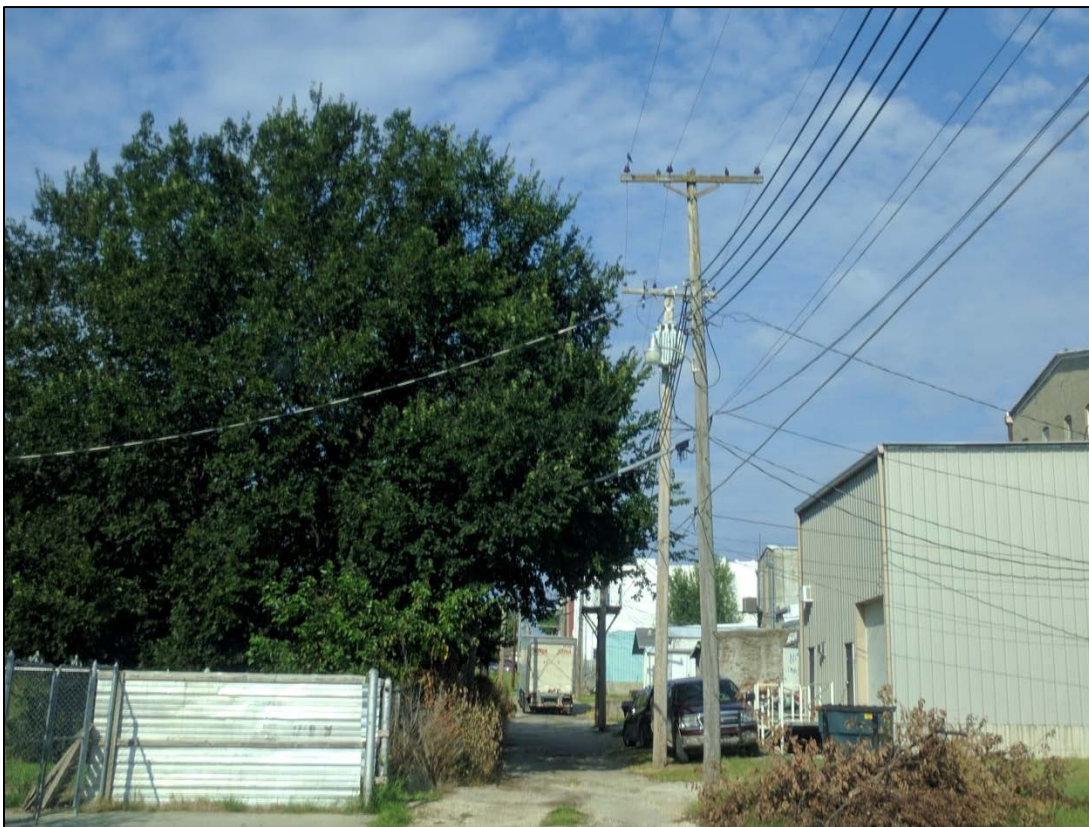
**Figure 3.4 - Tree Trimming**

Sega also recommends establishing a pole replacement program and a tree-trimming program. The linemen have already established a priority list for poles to be replaced soon which should be updated periodically, likely every two to three years. Allocating funds every year for this effort will maintain the system and keep it from falling behind on maintenance. Tree trimming had not been done in a couple years and there were a few places that needed some trimming. Creating a funding stream for a multi-year program to trim the entire system over a five-year period will keep the trees trimmed back and the line clearances maintained.
